## Gasket, cylinder-head for Engine Repair 195.470 for MAN D20 | 466.600 for MAN D26

SI 02/2023

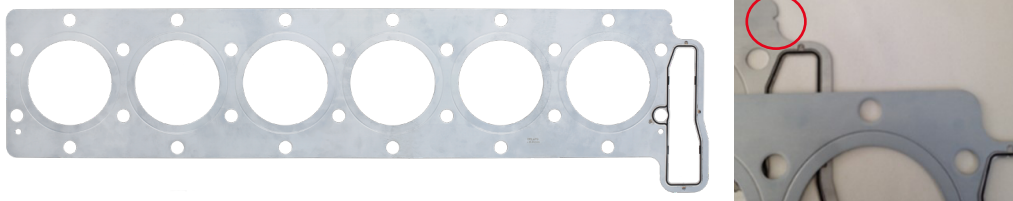
As can be seen in the image, in contrast to the standard gasket it has an additional notch at the front that is also clearly visible when it is installed.

The standard cylinder-head gaskets (thickness of 1.2 mm; Elring 021.262 or 357.831) are not intended for this purpose. The tooth flanks of the spur gears would otherwise interlock too closely with one another, which can rapidly lead to wear and damage. Elring has developed a 0.3 mm thicker cylinder-head gasket for carrying out long-term, environmentally friendly repairs on the engine. It compensates the removal of the material.

Important: It is extremely important to check the engine components that are affected by this modification (e.g. injection nozzle as a result of an excessive protrusion). We should like to expressly state that we assume no liability for the correct technical execution of the engine repair. This is the responsibility of the firm carrying out the repair work. Always observe installation and manufacturer information.
