Cylinder-Head Gaskets

Everything for a Reliable Seal.

Engine damage – caused by the cylinder-head gasket?

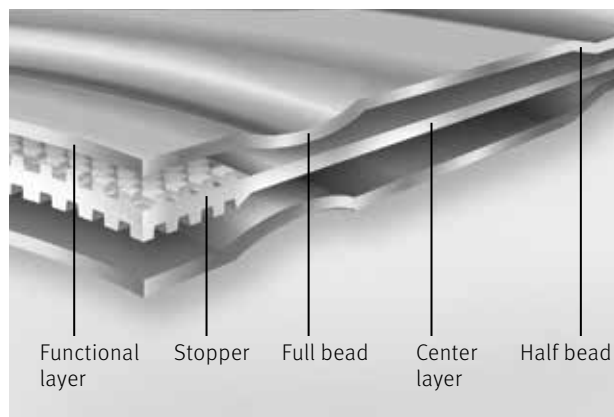
CENTER LAYER

The main function of the center layer is to adapt the gasket thickness to the installation conditions required by the overall design.

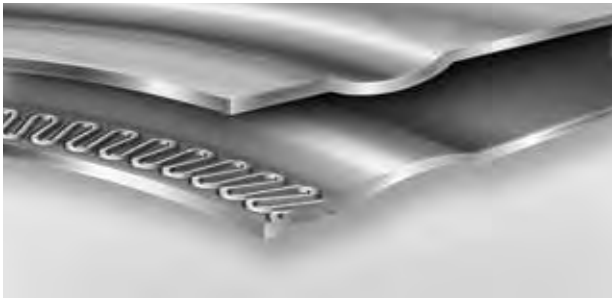
COINED STOPPERS

Serpentine stopper in functional layer

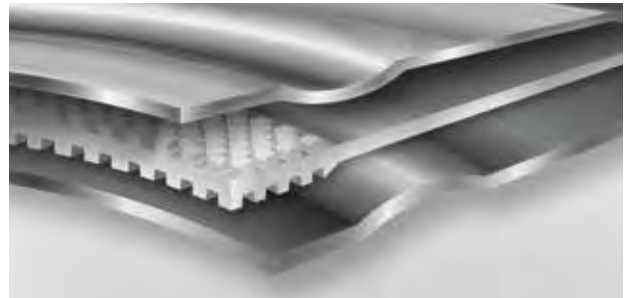
Honeycomb stopper in center layer

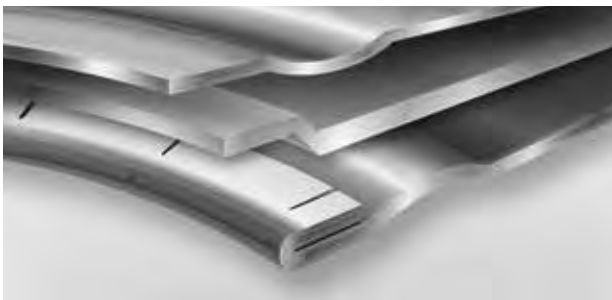
Segment stopper in functional layer

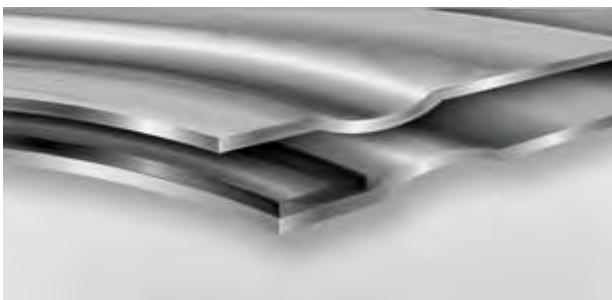
LASER-WELDED STOPPERS

Without carrier plate

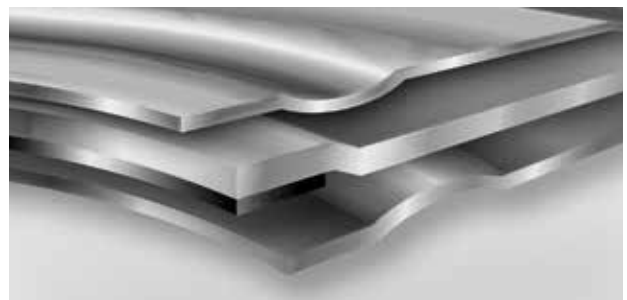
With carrier plate

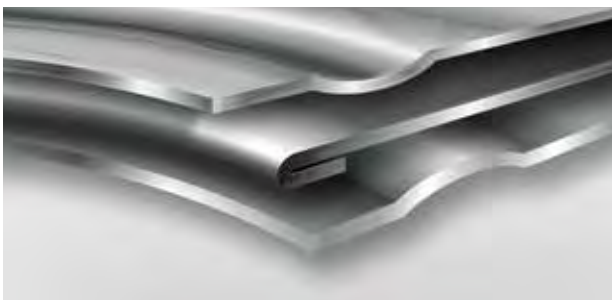
FOLDED STOPPER LAYER

Without carrier plate

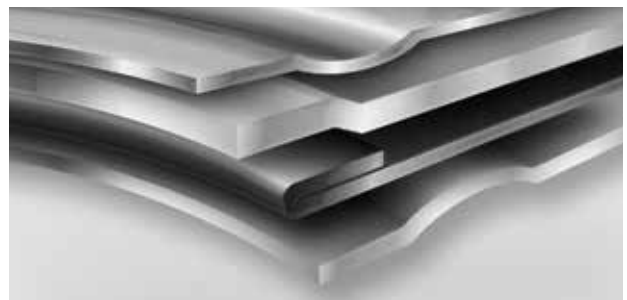
With carrier plate

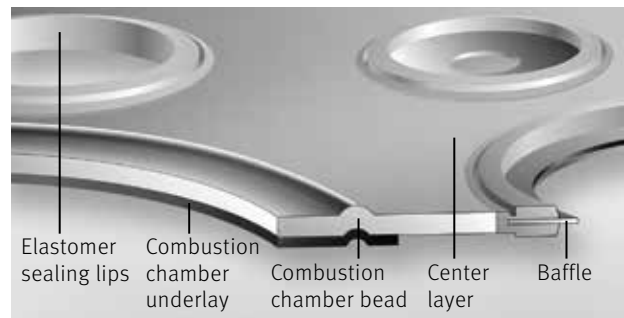
Single-layer solution

BAFFLE

Vulcanized baffles with various flow cross-sections are used for the purpose of controlling coolant flows.

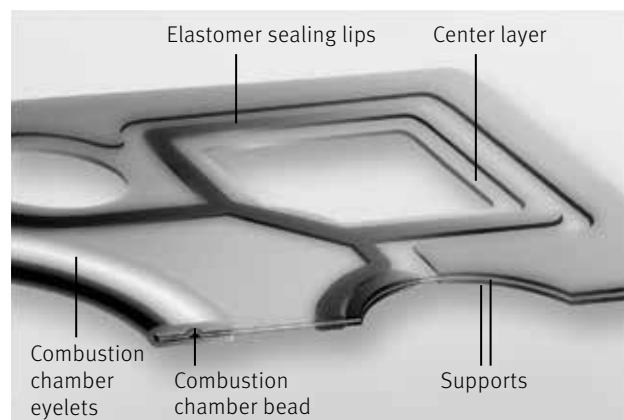
Multilayer solution

SUPPORTS

The metal supports that are used especially in multilayer versions help to restrict cylinder head flexing and also protect the elastomer sealing lips against excessive levels of compression.

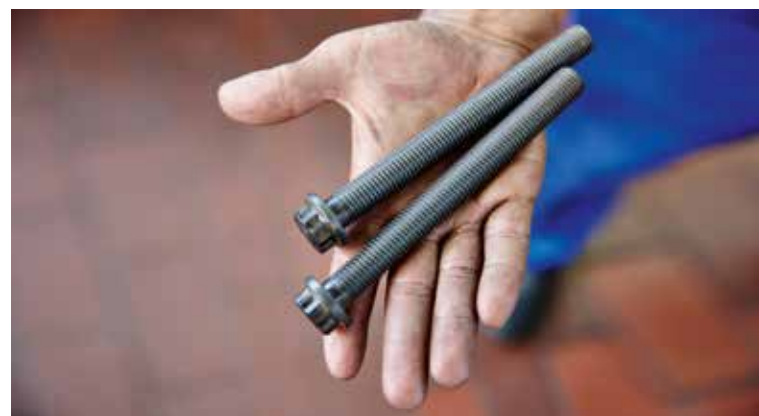
What is more, the new cylinder-head bolts must be tightened in accordance with the methods and procedures developed by engine and gasket manufacturers. The key characteristics of such bolts are best exploited if the appropriate torque and angle of rotation are observed. The bolts are tightened to a point beyond their yield strength until they enter the stage of plastic deformation.

Used bolts and bolts with evidence of elongation (coinciding with a reduction in the cross-section of the shaft and thread) no longer have the same properties as new bolts in respect of strength and elasticity. This in turn will lead to an impairment in the consistent distribution of tensile forces and elasticity within the bolt shaft, which are essential in the field of modern engine design when it comes to compensating for component elongation and any relative movements. Additionally, used bolts show signs of deformation in specific sections of the thread due to the high bolting forces (see image on the right). In their original state, the threads have a tolerance of 6 μ , which is in the hundredths of millimeter range. They no longer meet these specifications once they have been used. Cylinder-head bolts also have a specially developed surface coating to ensure favorable friction characteristics below the head section and within the threaded area. Only new bolts can achieve the requisite coefficient of friction of 0.12 – 0.14 μ .

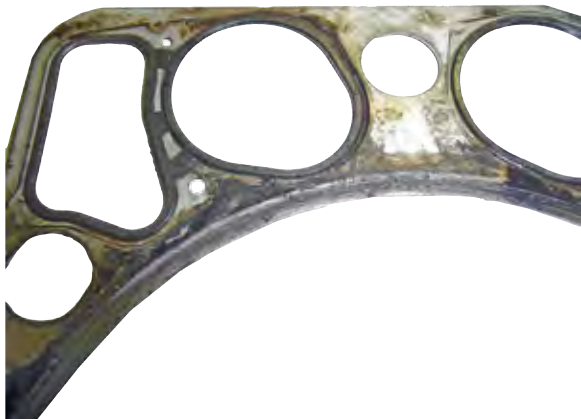
Over-blow of combustion gases at the combustion chamber eyelets of the cylinder-head gasket is one of the most common causes making it necessary to disassemble the cylinder head.

A clear indication is visible black discoloration on the metal eyelets or in the adjacent soft-material area of the gasket. Due to the high gas temperatures, the soft material at these points is overheated and can even burn. The gases often find their way into the cooling circuit. This is indicated by rising gas bubbles in the radiator or by the cooling circuit overheating (pressure in the cooling circuit increases and coolant escapes from the pressure relief valve, resulting in loss of coolant). In the worst case the eyelet is completely destroyed as a result. Uniform discoloration of the combustion chamber eyelets, however, can be regarded as normal and depends on the steel material and the surface coatings used.

In many cases, insufficient compression of the gasket in this area, which is subjected to very high temperatures, is a possible cause. This can be brought about, for example, by failure to subject the cylinder head to the specified tightening torque, failure to comply with the installation guidelines, or the use of old bolts. Components that are not flat (deformed) or have surfaces that are too rough also contribute to insufficient compression of the gasket. Unusually high engine loads in operation can also result in excessive thermal stress for the combustion chamber seal and consequently destroy it.

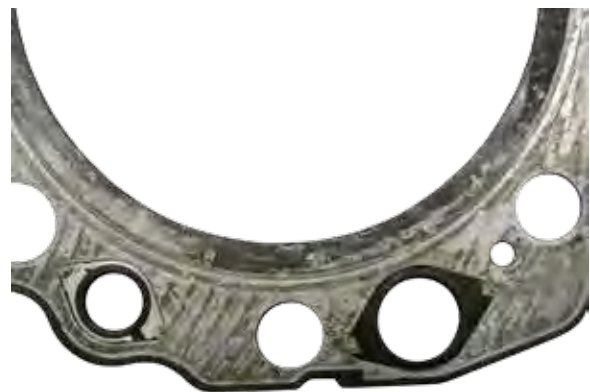
Very often, especially in the case of truck engines, the specified liner protrusion is not provided – due to lack of knowledge – or is adjusted incorrectly due to installation errors, the liner seating surface in the engine block was not reworked or the liner was not pressed into place properly. That causes the liners to drop, and the required sealing compression is lost. Combustion gases are now able to enter the rear areas of the gasket, where they then destroy the elastomer sealing elements or the soft gasket material in the water and oil openings.

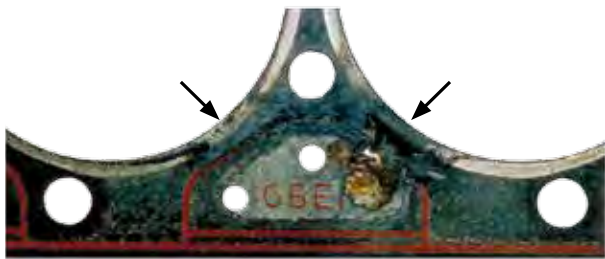
1. Failure of the cylinder-head gasket on commercial vehicles due to gas blow-by

DAMAGE SYMPTOMS

Between cylinders 2 and 3 (exhaust area) there is considerable gas over-blow. The soft material of the gasket has been destroyed in the area of the water holes.

CAUSE

The cylinder-head gasket was not compressed sufficiently because the bolts were not tightened in compliance with the method specified by the manufacturer. That caused gas blow-by into the cooling water. The result was an increase in coolant pressure, loss of coolant and destruction of the cylinder-head gasket.

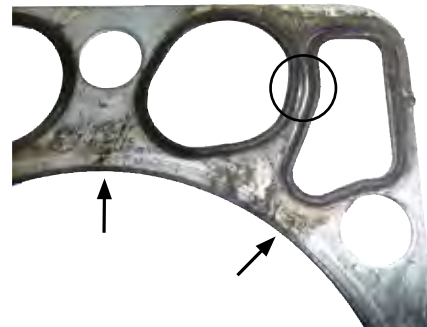
DAMAGE SYMPTOMS

The elastomer sealing element has become detached from the gasket carrier at the tappet opening. The same has occurred at the water opening, thus causing a significant loss of water.

CAUSE

An uneven cylinder head surface caused gas blow-by. The elastomer sealing elements were pushed away from the carrier plate by the high gas pressure. The destructive process was accelerated by constant full-load operation of the engine.

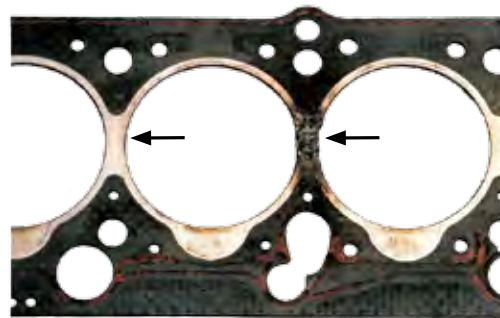
DAMAGE SYMPTOMS

Combustion chamber sealing web and soft material between cylinders 3 and 4 are scorched. Onset of dark discoloration between cylinders 3 and 4.

CAUSE

Uncontrolled combustion process caused the gasket material to overheat and ultimately destroyed it.

Before installation, inspect the injection nozzles carefully and check to make sure they are not leaking. After installation, check injection adjustment. Follow the general installation instructions issued by the engine manufacturers.

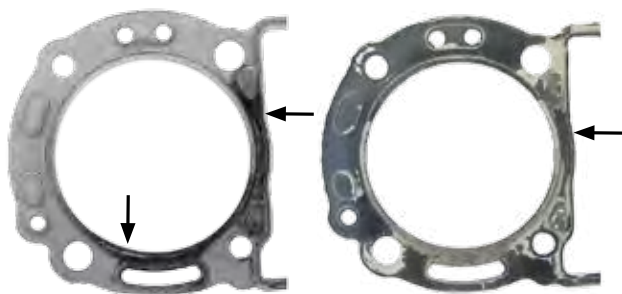
3. Failure caused by gas blow-by on 2-layer metal gasket for motorcycles

DAMAGE SYMPTOMS

The metal stopper layer and the functional layer show significant black discoloration near the cooling duct. Gas has leaked between the stopper layer and the functional layer.

CAUSE

Inadequate clamping forces due to insufficient bolt tightening torque, thus causing insufficient sealing compression.

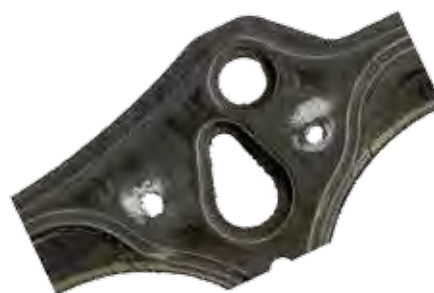
4. Failure due to pressure build-up in the cooling system as a result of gas blow-by

DAMAGE SYMPTOMS

On the multilayer metal cylinder-head gasket, distinct linear impressions can be seen in the area of the water ducts. These originate from the cylinder-head sealing surface and run toward the combustion chamber. The water passages are distinctly light-colored.

CAUSE

The surfaces of the cylinder head were machined either insufficiently or not at all. This resulted in blow-by of combustion gases into the cooling circuit and overheating (pressure build-up).

- The cooling system was not completely vented, thus preventing the circulation of coolant
- Cooling circuit interrupted (water pump, thermostat, fan)
- High exhaust back pressure caused the engine to overheat (e.g. defective catalytic converter)

Before installation, check the condition of the sealing surface very carefully and make sure the cylinder head and cylinder block are flat. Have them faced by a qualified contractor if necessary.

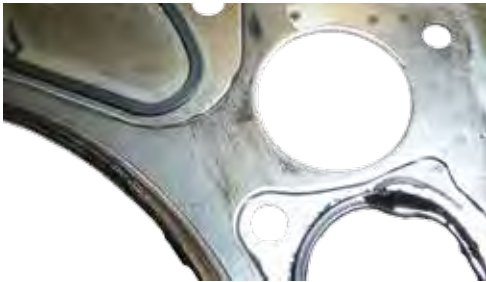
5. Failure of the cylinder-head gasket due to pressure build-up in the cooling system as a result of gas blow-by

DAMAGE SYMPTOMS

Clear linear impressions can be seen around the media openings. These originate from the cylinder-head sealing surface and run toward the combustion chamber.

CAUSE

The surface structure of the cylinder head was either machined too coarsely or not at all. This caused combustion gas blow-by into the cooling circuit and overheating (pressure build-up).

- The cooling system was not completely vented, thus preventing the circulation of coolant
- Cooling circuit interrupted (water pump, thermostat, fan)
- High exhaust back pressure caused the engine to overheat (e.g. defective catalytic converter)

Before installation, check the condition of the sealing surface very carefully and make sure the cylinder head is flat. Have it faced by a qualified contractor if necessary.

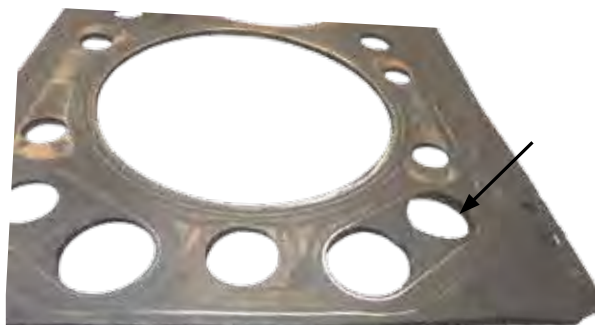
If the gasket is not aligned when the cylinder head was mounted, because the centering pins or sleeves are missing for example, leaks can occur. This occurs if the sealing elements of the cylinder-head gasket are not positioned exactly where they were designed to be. Cylinder-head gaskets installed in this way can often be recognized because of bolt through-holes having been deformed. Leaks are particularly common in pressurized oil bores if the cylinder-head gasket is misaligned.

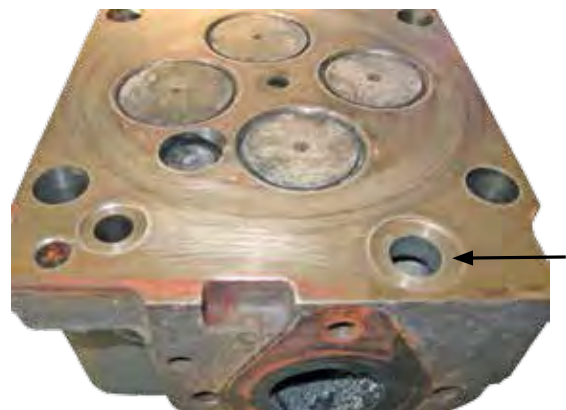
A truck engine developed a water loss that could not be detected from the outside. Cause: the cylinder liner had a porous area that was only visible under a microscope. When the engine was running, water got into the combustion chamber and evaporated. The cylinder-head gasket was not to blame in this case either – the cause was a material flaw in the form of a blowhole in the cylinder liner.

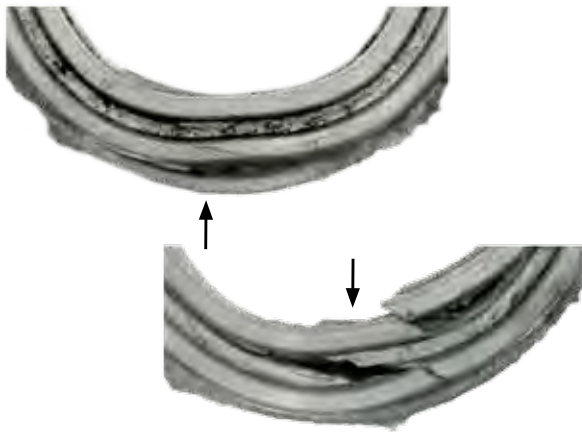
1. Failure caused by an oil leak, sealing element destroyed during installation of the cylinder head (truck)

DAMAGE SYMPTOMS

The elastomer sealing elements have been pressed away from the carrier plate and have been cut or torn.

Take great care when preparing and performing the installation work. If the cylinder head needs to be mounted a number of times, the gasket must be inspected for damage.

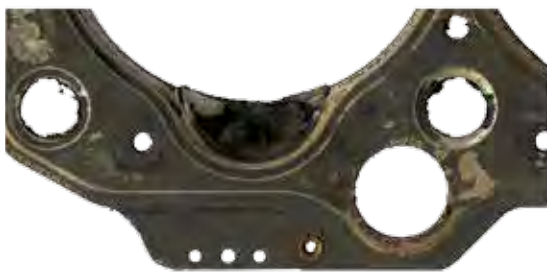
DAMAGE SYMPTOMS

The variable tumble control system plate area of the multilayer metal cylinder-head gasket is badly damaged due to mechanical action.

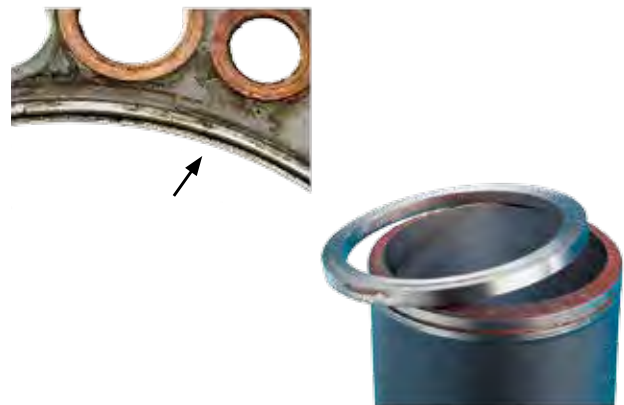
The metal combustion chamber eyelets of the cylinder-head gasket were completely compressed together internally by the collar of the liner. The collar of the liner was blasted away by the extreme forces when starting the engine – the result was serious engine damage.

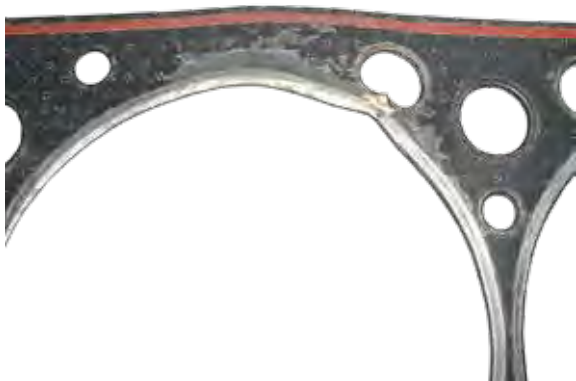
Very often this is associated with knock damage in gasoline engines, resulting in uncontrolled combustion processes.

This is problematic because of the resulting thermal and mechanical overload on the components. The cylinder-head gasket is one of the most susceptible engine parts and it can only withstand this extreme stress for a short period of time. The uncontrolled combustion process generates shock waves accompanied by an extremely rapid increase in pressure (over 100 bar) and also high temperatures (well over +3,700°C). In many cases, crushed combustion chamber eyelets are evidence of cylinder-head gaskets affected by knock damage.

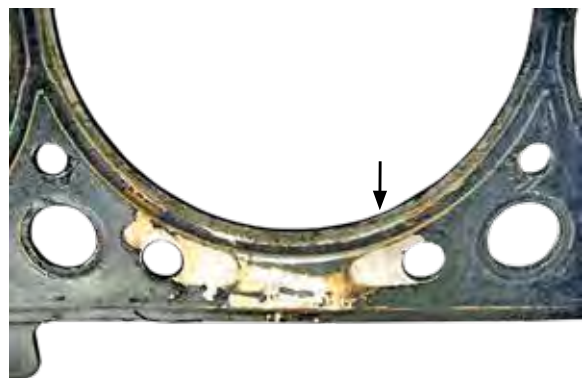
Onset of black discoloration in the sealing web area of the functional layer points to the destruction process, triggered by unprofessional chip tuning.

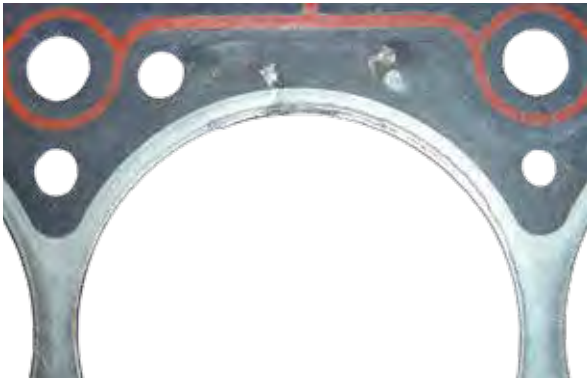
Recesses and deformations can be clearly seen on the metal combustion chamber eyelets. This causes the eyelets and the soft material to fuse. At these points the bare metal of the combustion chamber eyelets can usually be seen and the soft material shows traces of burning.

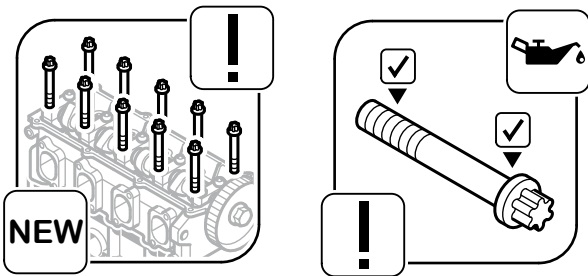
6. CYLINDER-HEAD BOLTS

- Always fit new cylinder-head bolts and washers
- Lightly lubricate threads and bolt seat surfaces with oil

- If a washer is also being fitted, only apply oil between it and the bolt head
- Important: Under no circumstances should the seat surface of the washer be oiled on the cylinder head
